Methods of validation of occupational noise exposure measurement with multi aspect personal sound exposure meter

ABSTRACT

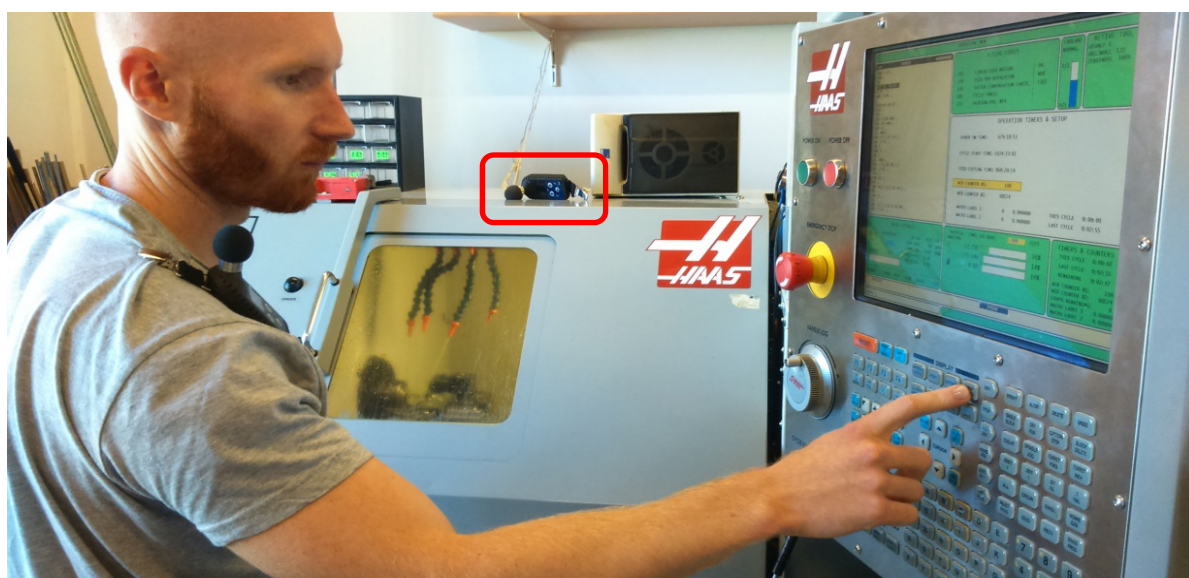
Figure 3: Worker operating CNC machine, left shoulder PSEM detached and positioned on CNC chamber

The left hand device was also removed from the workers shoulder twice, for an overall period of approximately 1 hour 12 minutes. During these periods the PSEM was “parked” on top of the CNC machine to simulate worker manipulation of the apparent daily occupational noise exposure.

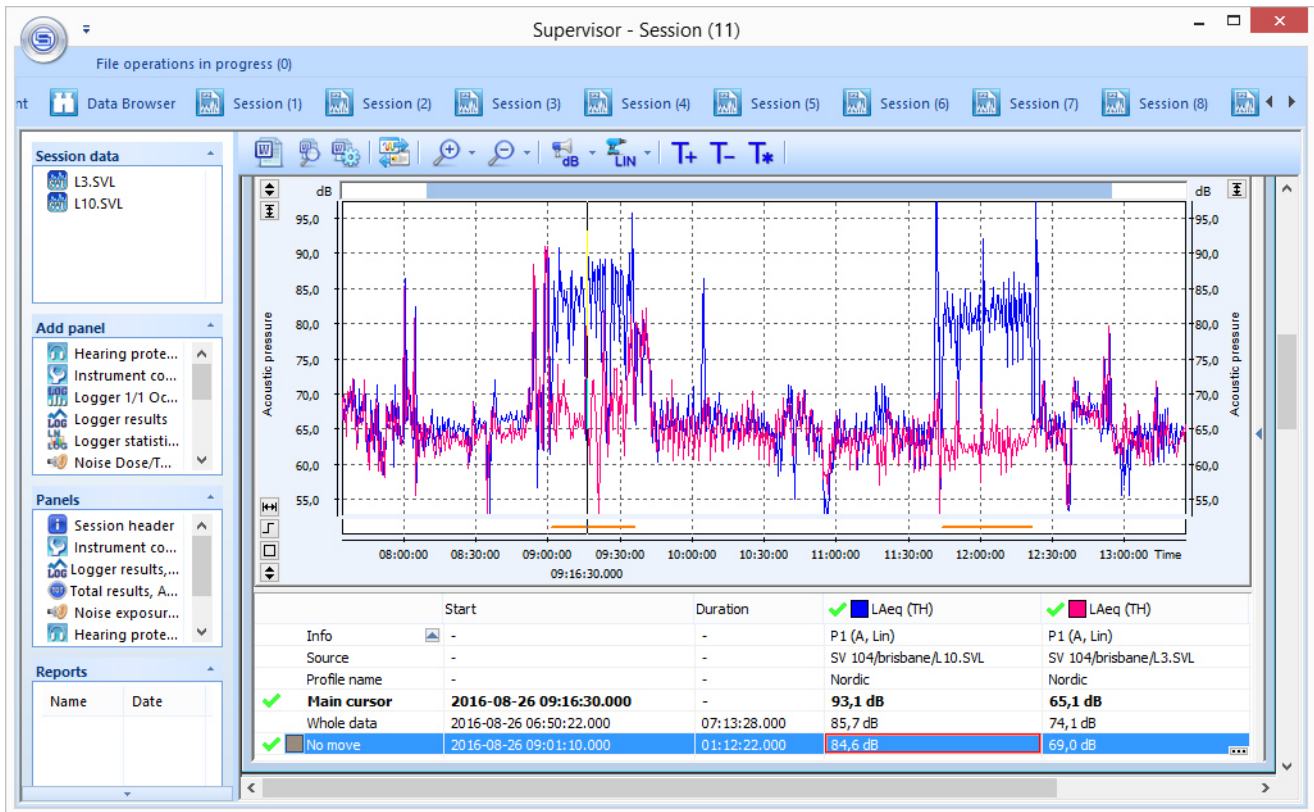
Figure 5: Full day measurement L_{Aeq} overview from both instruments

Two periods of no movement were noted in the left shoulder PSEM record, these are highlighted with an orange marker in the time history shown in Figure 5. The periods sum to a total of 1 hour 12 minutes and are responsible for 13.7 percentage points of the daily dose. The events shown can be matched to the period of time when the instrument was removed by the worker and placed on top of the CNC chamber.

Figure 5 allows comparison of the time history from the left and right shoulder PSEM. Left shoulder – blue trace, including those periods where the meter was removed and placed on top of the CNC machine (L_{Aeq} , average over the 1 hour 12 minutes period was 84.6 dBA) and right shoulder – red trace (remaining on the worker’s shoulder, average L_{Aeq} , over the same period, 69.0 dBA). During the period, the worker remained within 0.5 – 2.5 m of the CNC machine.
