Methods of validation of occupational noise exposure measurement with multi aspect personal sound exposure meter

Marek Podgórski

Svantek Sp. z o.o., Warsaw, Poland

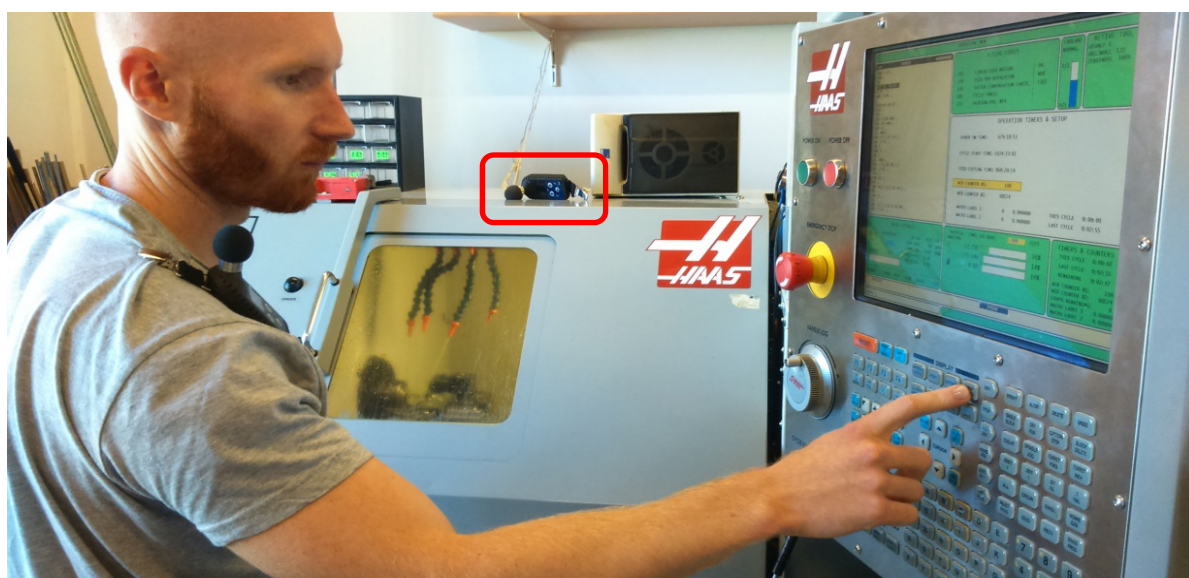
Figure 3: Worker operating CNC machine, left shoulder PSEM detached and positioned on CNC chamber

The left hand device was also removed from the workers shoulder twice, for an overall period of approximately 1 hour 12 minutes. During these periods the PSEM was “parked” on top of the CNC machine to simulate worker manipulation of the apparent daily occupational noise exposure.
